SUBJECT: Clutch Yoke 40-781 in
LA-5 and LA-6 machines.

DATE: July 25, 1934

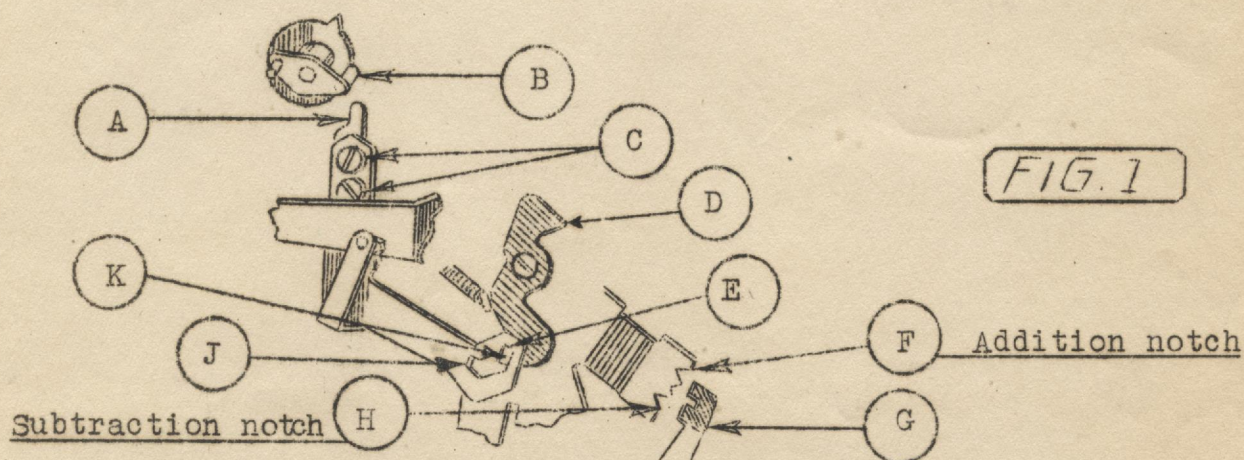
Continuous Running of Machine in Addition or Subtraction

This rocking motion is caused by the failure of offset (K) to unlatch from position (J) before the clutch yoke click enters the addition notch in the clutch yoke, thereby causing the 4708 blank (A) to continue in the path of the 4757 stud (B) on the crank arm. As the cycle stopping arm returns to the bumper pad after the final tripping of the trip lever the clutch yoke fails to neutralize due to the 4757 stud (B) engaging the 4708 blank (A) and causing the clutch yoke click (G) to seat in either the addition (F) or subtraction (H) notch in the yoke resulting in the machine running continuously.

To overcome this condition adjust the 4708 blank (A) to the 4757 (B) stud by loosening screws (C) and positioning blank (A) upward, downward, forward or rearward to suit in relation to stud (B) as follows.

- 1 When offset (K) is positioned at (E) and the clutch yoke click engages either of the three notches "add, subtract or neutral," the stud (B) should not engage the 4708 blank (A)
- 2 When offset (K) is located in position (J) and the clutch yoke click (G) is in the neutral notch of the clutch yoke, stud 4757 (B) should strike the rear of blank 4708 (A) with sufficient force to position the clutch yoke click (G) in the subtraction notch (H). When click (G) is in neutral, stud (B) should strike blank (A) and cause the clutch yoke click (G) to move into the addition notch (F). When (K) is in position (J), and (G) is in either of notches (F) or (H), stud (B) should not engage (A).

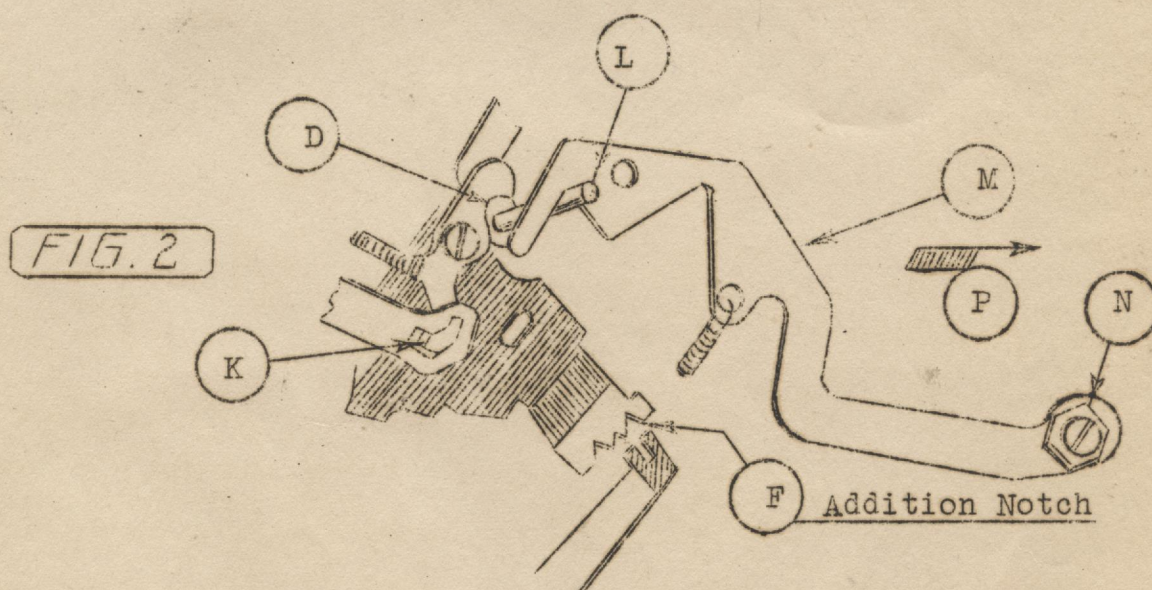
"Nines" Remaining in Lower Dials

This condition is caused by offset (K) unlatching too quickly, thereby causing the clutch yoke to neutralize instead of the clutch yoke click entering the addition notch thereby allowing the mechanism to make an addition cycle which would clear out the "nines."

This condition may be remedied by adjusting the division lever click (M) in direction of arrow (P) by means of eccentric nut (N) thereby increasing the clearance between the latch (D) and stud (L).
